NEWSLETTER

BRUNSWICK COUNTY HISTORICAL SOCIETY
BRUNSWICK TOWN, P.O. BOX 356, SOUTHPORT, N.C.

May, 1978

BRUNSWICK TOWN PROJECTS

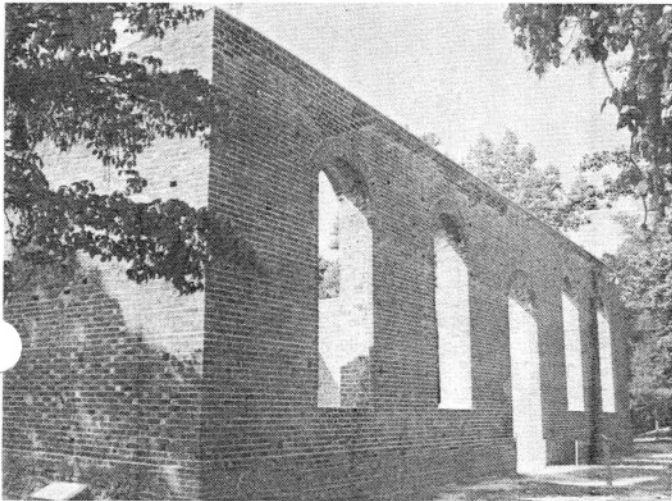
St. Phillip's Church - Stabilized.

One of the most significant, and probably least noticed, projects is the stabilization of the St. Phillip Church walls. Constructed between 1754-68, and burned by the British during the American Revolution, time and the elements have been no ally to its preservation. In 1862 Fort Anderson was constructed over the Northern portion of the abandoned Colonial town-site and the walls of the church were incorporated inside the fort. Changes in temperature between the heat of summer and the cold of winter, especially a freezing rain, caused the brick to spall or erode and the mortar to become soft. This condition tends to attract a particular breed of persons who help this natural erosive process along by removing loose material, carving names, initials and dates in the brick which caused more erosion — and the process repeats itself.

Restoration Specialists of the Department of Cultural Resources met with private contractors and consulting engineers and it was decided not to place a roof over the existing walls as a measure of protection. It was decided to remove the spalled brick and loose mortar and to replace the brick with a new brick meeting the physical size and color specifications of the original brick. A formula for mortar was determined to assure compatibility of hardness, texture and color and the stabilization project was begun. (The consulting engineers report, substantiated by archaeology, revealed that the existing walls were still structurally sound and would support a roof.) The archaeological investigation revealed that the wall footings were 36" below the original construction level and 42" below the present ground level, denoting a 6" build up in soil during

A waterproof cap was poured atop the 33" thick walls to prevent water from seeping through the top to bottom, freezing and causing more damage to occur from this action of the elements. The stabilization project was completed, and the work was accepted by the State.
